# **CAMP SPELMAN LAKE DAM CONDITIONS AND RECOMMENDATIONS REPORT**

## **Portage Park District**

**Environmental Design Group Project No. 21-00430-010**

**September 8, 2021**

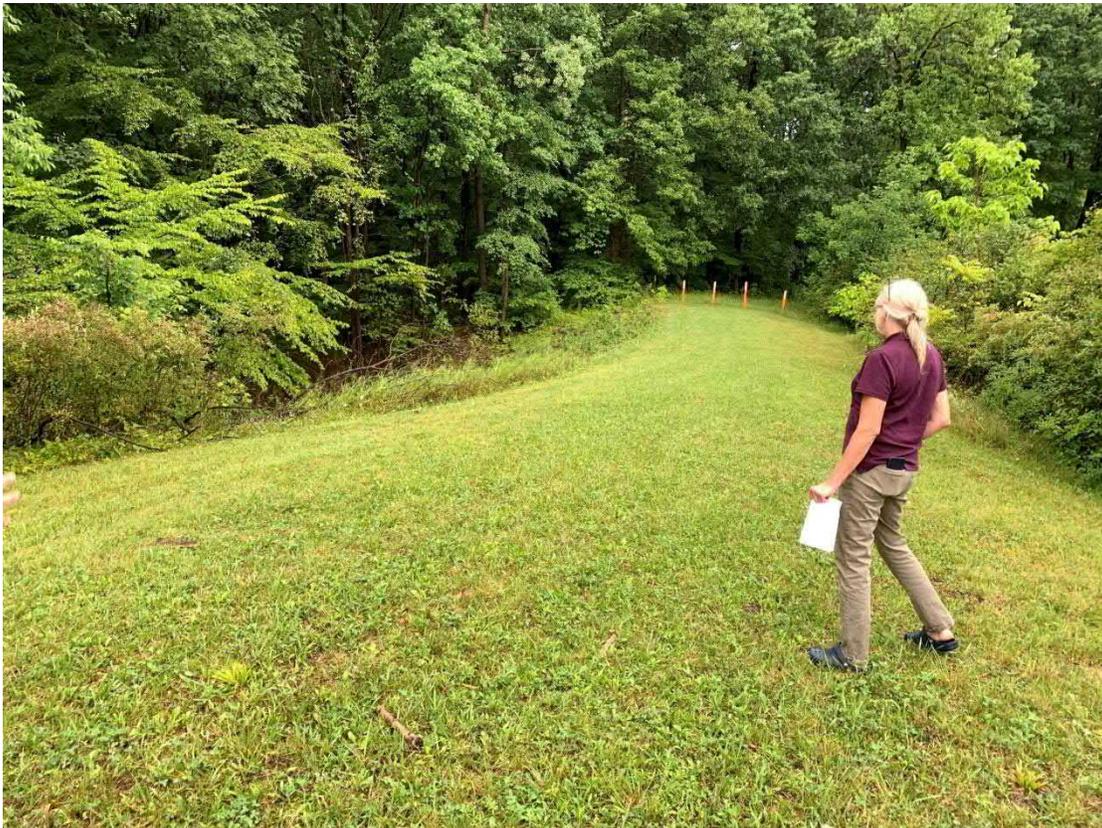
FIGURE 4 - PRINCIPAL DAM, DAM CREST

**Crest:** The crest was measured at 195 feet long. The crest was found to have a satisfactory grass cover. However, the vertical alignment of the crest varies by 1-2 feet.

5. Reshape/Level Top of Dam Embankment: Reshape the top of dam to an elevation of 1088.50 feet. Based on EDG's survey and preliminary H&H calculations for the proposed emergency spillway modification described above, this elevation would pass the design storm without the dam overtopping. This involves reshaping (raising and lowering) the crest of the main embankment to maintain a uniform elevation. As necessary, suitable/properly compacted fill material will be required to fill-in low portions of the dam and any unsuitable material (sand, gravel, etc.) will need to be removed from the embankment surface before placing and compacting this fill. This type of modification to the dam embankment must be designed by a registered PE, be constructed under the supervision of a registered PE, and have the construction certified by a registered PE. A registered geotechnical PE that is hired by the owner, not the contractor, will need to perform material and compaction testing for fill placed during this modification as well. The final top of dam elevation may be refined during detailed design or based upon ODNR's comments.

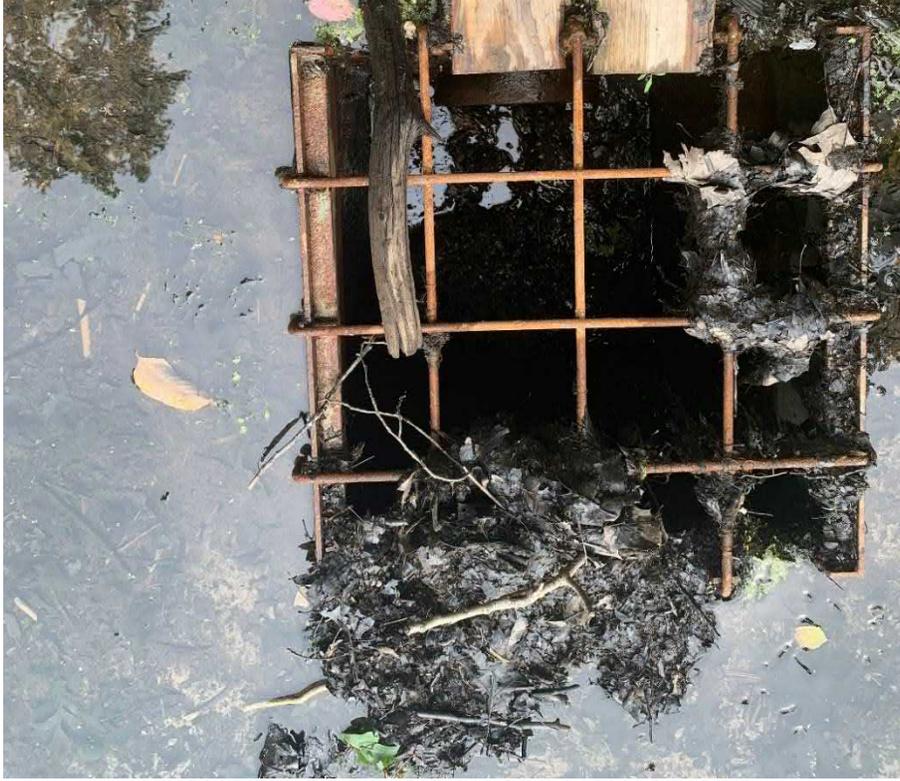
FIGURE 5 - PRINCIPAL SPILLWAY RISER

The principal spillway was found to be a pipe and riser system (**Figure 5**). The riser is a 24-inch-square concrete box riser, and the outlet pipe is 90 feet of 12-inch-diameter PVC pipe. The principal spillway rim elevation was surveyed at 1084.66-feet while the emergency spillway elevation starts activating at 1085.35-feet. The spillway outlet did not have an erosion control structure; however, little erosion was found (**Figure 6**). The riser includes a trash rack with flat bars laying directly on the orifice. An anti-vortex device was not found. Arden Sommers stated that beavers obstruct the principal spillway riser grate with debris and that he is frequently cleaning the existing grate.

Replace the trashrack at the inlet of the principal spillway and install a suitable anti-vortex plate similar to that shown in **Figure 9**. See ODNR fact sheet “Design and Maintenance of Trashracks for Pipe and Riser Spillways”. For this

dam's 24-inch x 24-inch structure with a 12-inch outlet pipe, the openings in the trashrack bar mesh openings should be at least 6 inches x 6 inches. The trashrack should be securely fastened to the inlet so that it can withstand the hydrostatic and dynamic forces exerted on the trashrack during periods of high flow. The anti-vortex plate increases the capacity of the spillway by preventing the formation of a flow inhibiting vortex during periods of high flow. This is a repair that does not require the services of a professional engineer; however, EDG recommends that this new trashrack and anti-vortex plate be coordinated with ODNR staff prior to installation so that they confirm the proposed device(s) would be acceptable.

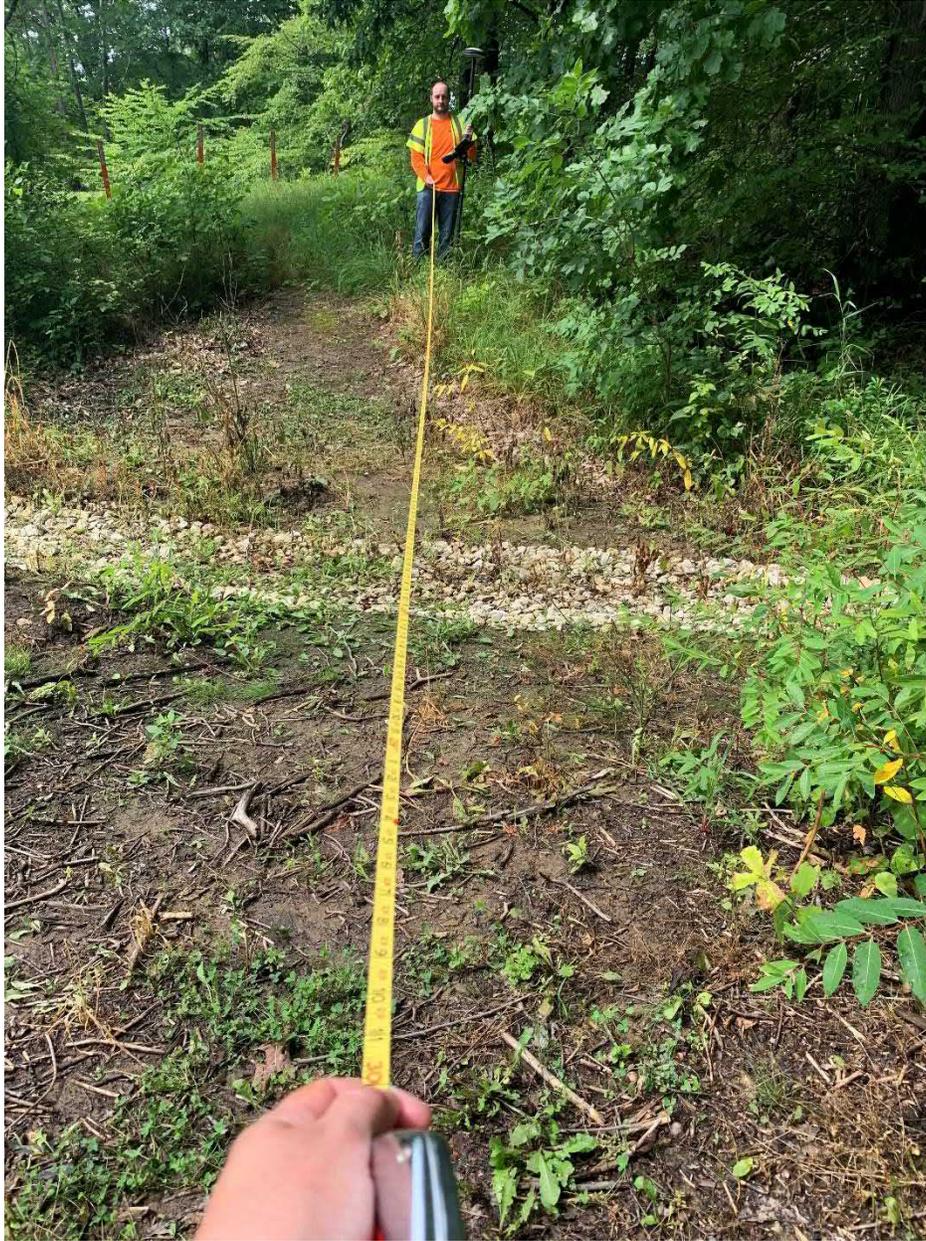
**FIGURE 7 - SURVEYED PORTION OF EXISTING EMERGENCY SPILLWAY SECTION**

The emergency spillway was found to be a two-stage, trapezoidal-shaped open channel and a portion of this cross section was surveyed (**Figure 7**). Looking downstream, the left side slope of this cross-section is 4.5H:1V (according to EDG's

survey data) while the right-side slope is estimated to be 6H:1V (according to topographic contours generated from OSIP LiDAR data). The first stage was found to be approximately 8-feet wide, while the second stage was found to be approximately 74-feet wide, which is similar to the dimensions found by ODNR. Brush was found at the channel inlet and mature trees were located throughout the channel. The channel discharges in the direction of homes located on Westlake Blvd.

4. Modify/Clear/Revegetate the Existing Emergency Spillway: Based on our preliminary H&H calculations, the existing emergency spillway could be raised to create a trapezoidal-shaped opening that passes the design storm. This trapezoidal-shaped opening would have a 20-foot-breadth level crest section at an elevation of 1086.50 feet that is approximately 74 feet wide and has side slopes ranging from ~4.5H:1V to ~6H:1V. (Figure 12). This would raise the emergency spillway elevation enough so that it does not activate during the 100-year design storm event. This type of modification to the emergency

spillway must be designed by a registered professional engineer (PE) as well as be constructed under the supervision of a registered PE and have the construction certified by a registered PE. A registered geotechnical PE that is hired by the owner, not the contractor, will need to perform material and compaction testing for fill placed during this modification as well. The final size and elevation may be refined during detailed design or based upon ODNR's comments but based on our current modeling results this is appropriate to pass 100% of the PMF/design flood without overtopping the proposed top of dam elevation discussed below.

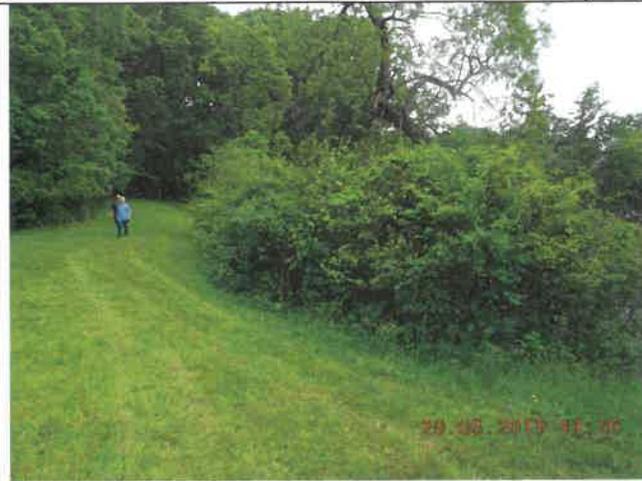
Trees and brush along the upstream slope.

3. Remove Trees/Brush from the Dam Embankment: Remove the trees and brush from the entire main embankment and seed all disturbed and bare areas to establish a proper grass cover. Although the existing trees on the downstream dam face have been cut down, the stumps and roots still need to be removed to at least 6" below grade then the cavities backfilled with well-compacted soil and vegetated with grass (See ODNR Fact Sheet "Trees and Brush"). To establish the grass, additional trees near the dam abutments may need to be cleared.

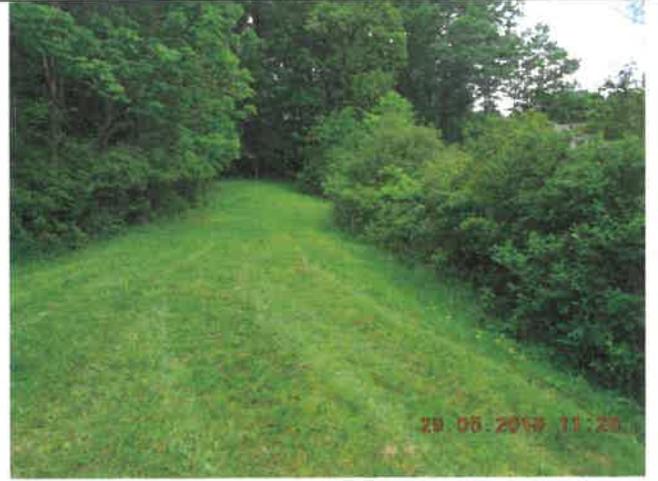
View of the dam crest from the left abutment. Note the dense trees and brush on upstream and downstream slopes.

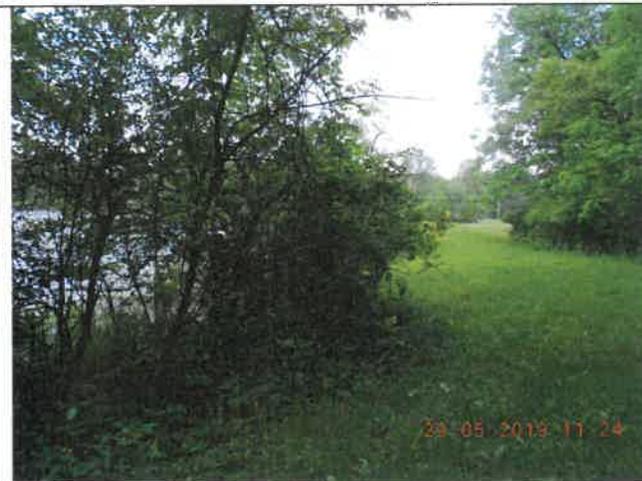
View of the upstream slope and crest from the right abutment. Again notice the trees and brush on the slopes.

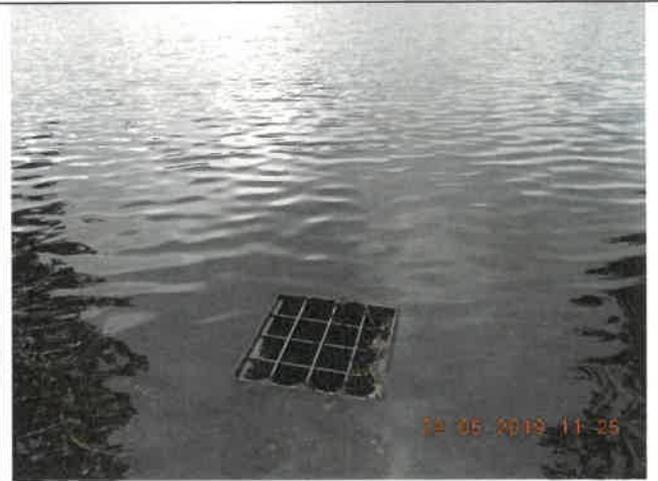
View of the principal spillway riser.

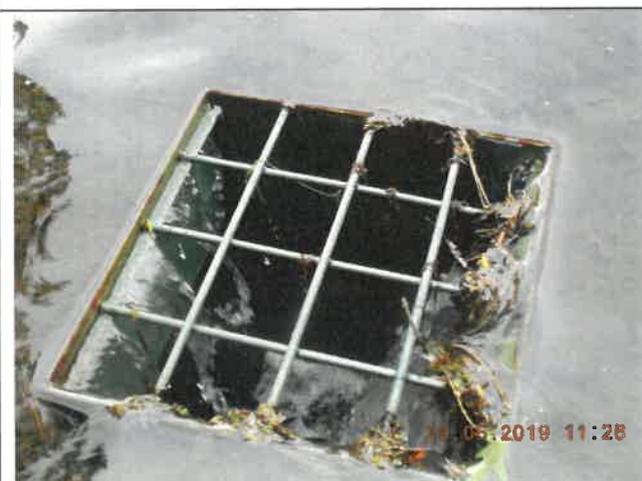
Close-up of the principal spillway trashrack. Note the debris collection of the flat bars.

2. Replace the trashrack with an acceptable device and install an anti-vortex device at the inlet of the principal spillway. See the "Design and Maintenance of Trashracks" fact sheet for additional information.

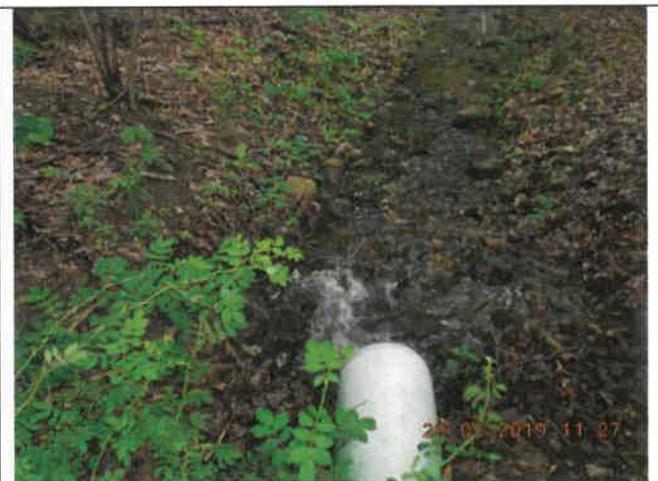
View of the principal spillway outlet.

5. Monitor the erosion at the principal spillway outlet. See the "Open Channel Spillways (Earth and Rock)" fact sheet for additional information. Please note that engineered repairs may be needed if this problem worsens.

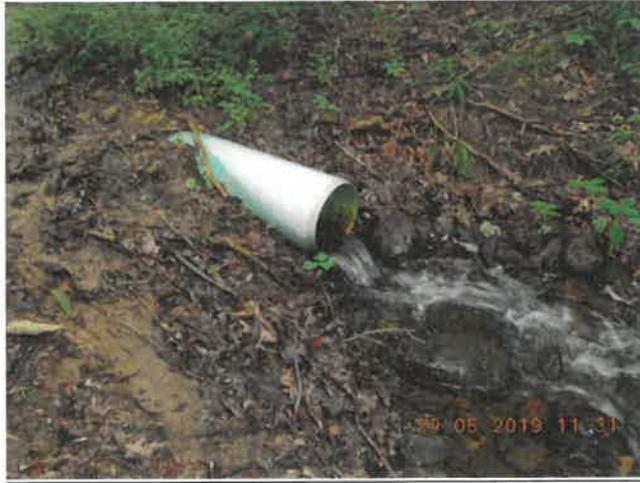
Another view of the principal spillway outlet.

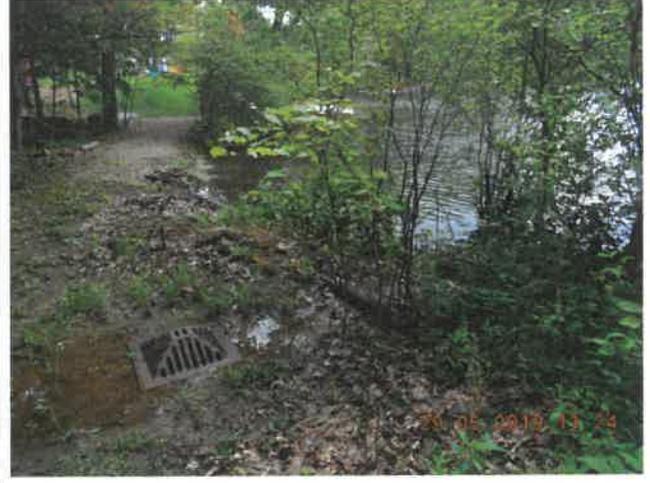
View of the emergency spillway. Note the trees and brush at the inlet.
