### ***Towner's Woods Park: House and Poolhouse Building Asbestos Abatement and Demolition/Removal***

Towner's Woods Park: 2241 Ravenna Rd. House and Pole Building Demolition

## Asbestos Hazard Assessment Final Report

Emerald Job Number	13540
Site Name	Portage Park District
Site Street Address	2241 Ravenna Road
Site City	Kent
Site Zip Code	44240
Build Year	1960
Square Footage	1560

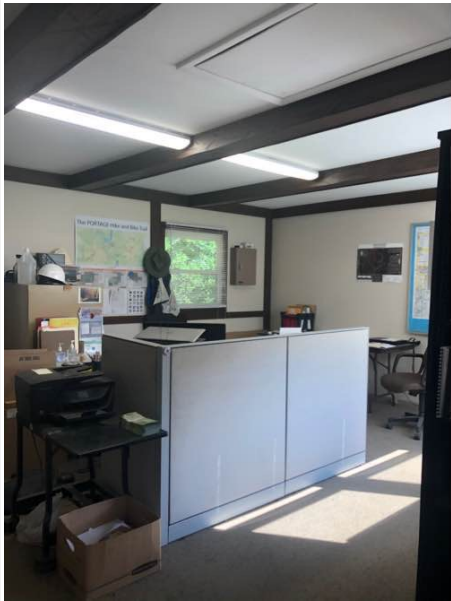
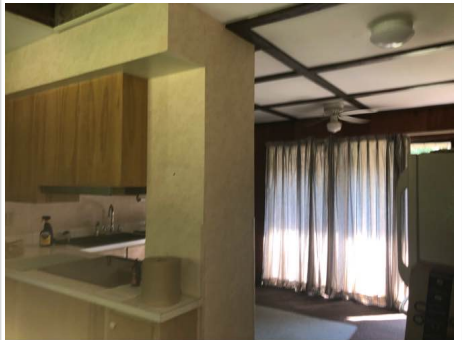
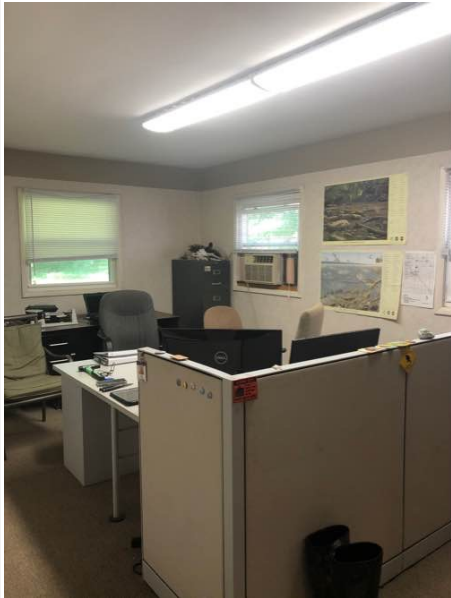
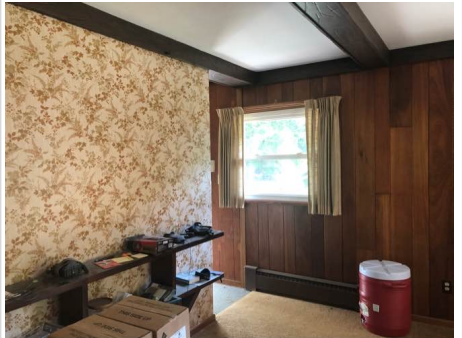
<b>Material Description</b>	Plaster ceiling	
<b>Homogeneous Area</b>	PC-1	
<b>Material Quantity</b>	1600 SF	
<b>Is the material Asbestos Containing?</b>	No	
<b>Material Location</b>	Throughout main floor	
<b>Material Photos</b>

<p>Typical view of plaster ceilings</p>

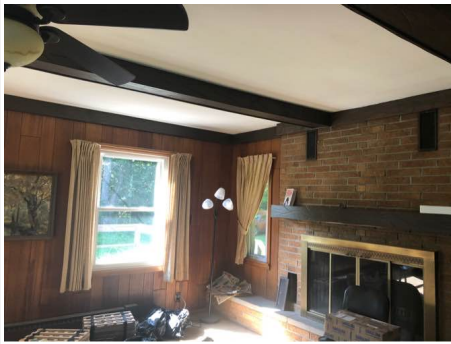
<b>Material Description</b>	Drywall ceiling and joint compound
<b>Homogeneous Area</b>	DC-1
<b>Material Quantity</b>	1600 SF
<b>Is the material Asbestos Containing?</b>	Yes
<b>Type of Asbestos</b>	Chrysotile
<b>Percentage</b>	2
<b>Was the sample point counted?</b>	No
<b>Condition</b>	Friable
<b>Material Location</b>	Throughout main floor beneath plaster
<b>Material Photos</b>

<p>Typical view of plaster ceiling on drywall ceilings</p>

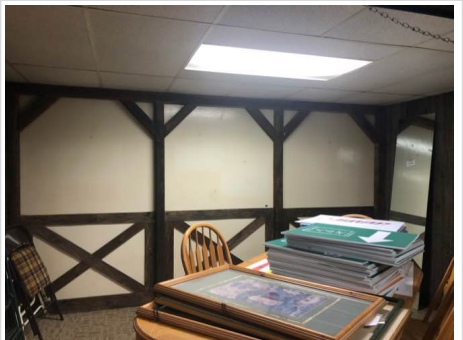
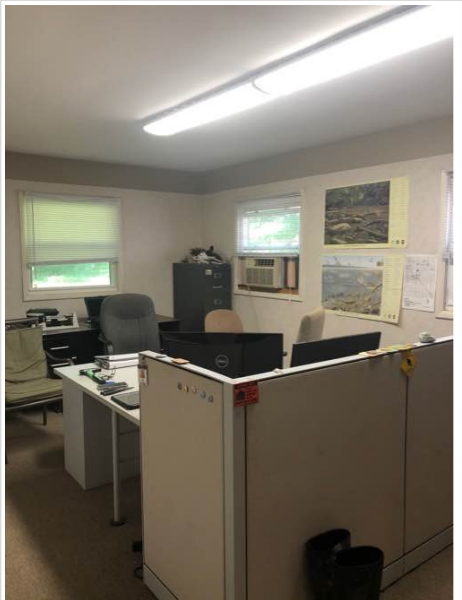
<b>Material Description</b>	Drywall walls and joint compound
<b>Homogeneous Area</b>	DWJ-1
<b>Material Quantity</b>	3000 SF
<b>Is the material Asbestos Containing?</b>	Yes
<b>Type of Asbestos</b>	Chrysotile
<b>Percentage</b>	2
<b>Was the sample point counted?</b>	No
<b>Condition</b>	Friable
<b>Material Location</b>	Throughout main floor and portions of the basement

<p>Typical view of drywall walls in basement</p>

<p>View of drywall walls on the 1st floor</p>
-----------------	--	--

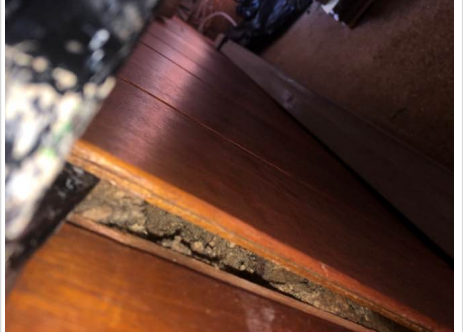
Material Description	Blown in insulation	
Homogeneous Area	BI-1	
Material Quantity	1000 SF	
Is the material Asbestos Containing?	No	
Material Location	South exterior wall	
Material Photos

<p>View of blown in found in the south exterior wall in the family room</p>

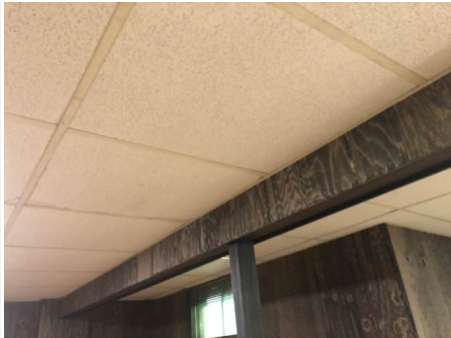
Material Description	Ceiling panel large holes	
Homogeneous Area	CP-1	
Material Quantity	700 SF

Is the material Asbestos Containing?	No
Material Location	Basement
Material Photos

<p>Typical view of ceiling panels with large pinhole texture</p>

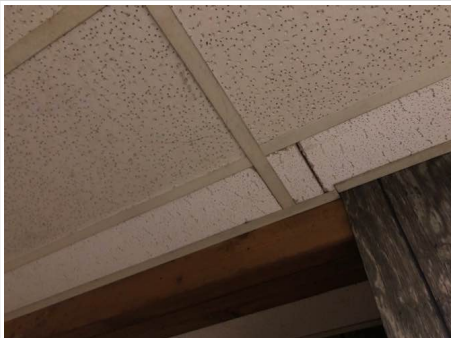
Material Description	Ceiling panel worm texture
Homogeneous Area	CP-2
Material Quantity	25 SF
Is the material Asbestos Containing?	No
Material Location	Basement
Material Photos

<p>View of large pinhole and worm texture ceiling panels</p>

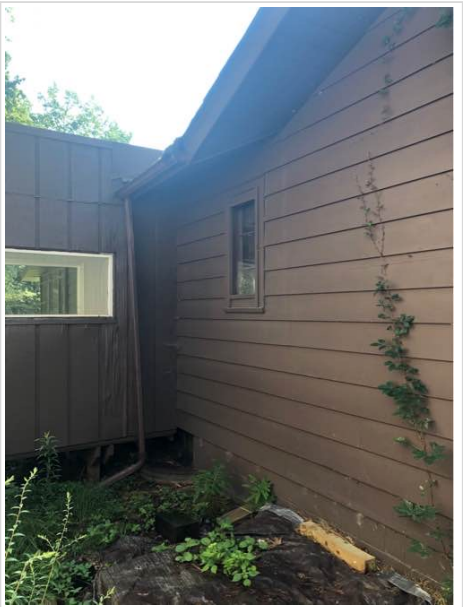
Material Description	Window caulking
Homogeneous Area	WC-1
Material Quantity	3 SF
Is the material Asbestos Containing?	No
Material Location	Exterior window, 1

<p>View of the window with window caulking and glazing</p>	
-----------------	--	--

Material Description	Window glazing
Homogeneous Area	WG-1
Material Quantity	3 SF
Is the material Asbestos Containing?	Yes
Type of Asbestos	Chrysotile
Percentage	2
Was the sample point counted?	No
Condition	Friable
Material Location	Exterior window, 1

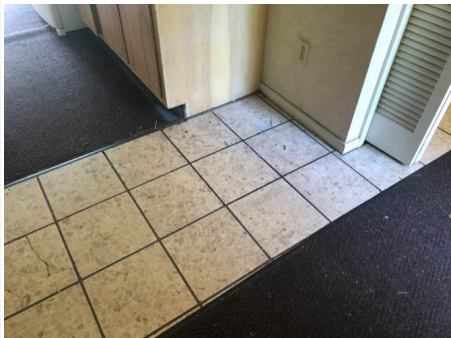
Material Description	Ceramic floor tile and adhesive, stone pattern
Homogeneous Area	CT-1
Material Quantity	100 SF
Is the material Asbestos Containing?	Yes
Type of Asbestos	Assumed
Condition	Non-Friable

<p>View of the ceramic floor tile at the entry way</p>

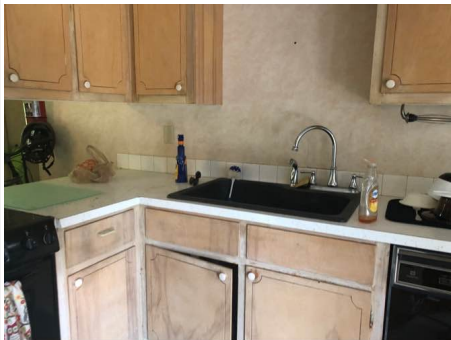
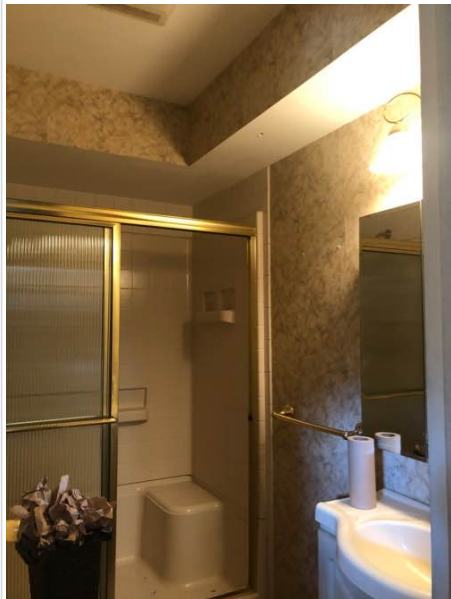
<b>Material Description</b>	Ceramic wall tile and adhesive, white
<b>Homogeneous Area</b>	CT-2
<b>Material Quantity</b>	20 SF
<b>Is the material Asbestos Containing?</b>	Yes
<b>Type of Asbestos</b>	Assumed
<b>Condition</b>	Non-Friable
<b>Material Location</b>	Kitchen, bathroom
<b>Material Photos</b>	<div>

<p>Ceramic wall tile in kitchen</p> </div> <div>

<p>Ceramic wall tile above and beside the shower</p> </div>

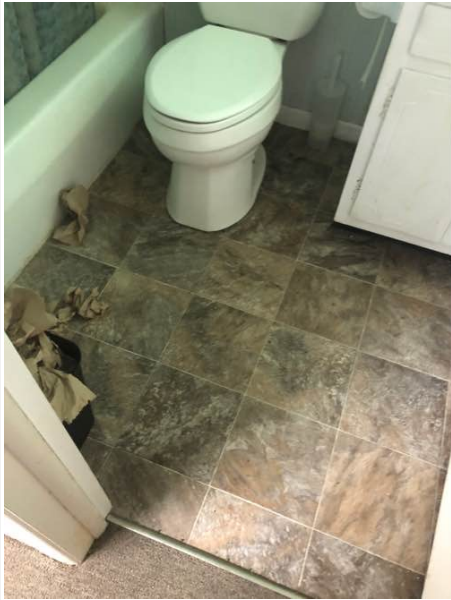
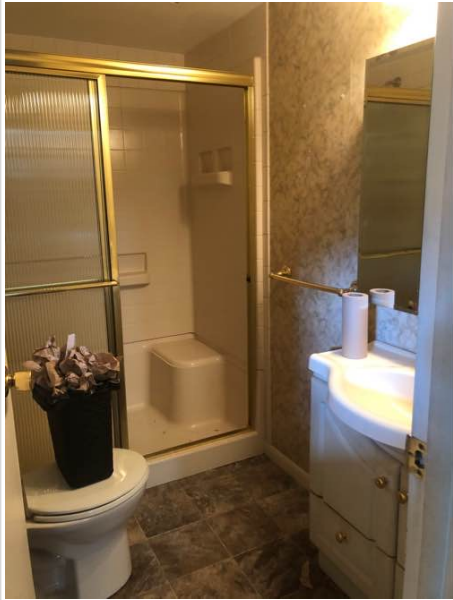
<b>Material Description</b>	Brown sheet floor and adhesive
<b>Homogeneous Area</b>	SF-1
<b>Material Quantity</b>	80 SF
<b>Is the material Asbestos Containing?</b>	Yes
<b>Type of Asbestos</b>	Assumed
<b>Condition</b>	Non-Friable
<b>Material Location</b>	Bathrooms on main floor
<b>Material Photos</b>

<p>View of brown sheet floor</p> <p>View of brown sheet floor</p>

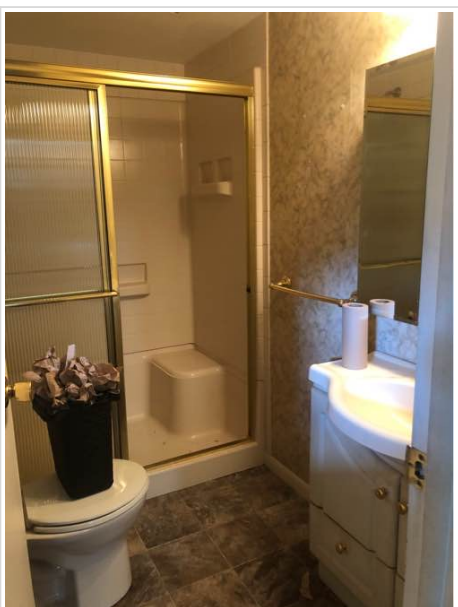
<b>Material Description</b>	Shower surround main floor
<b>Homogeneous Area</b>	SS-1
<b>Material Quantity</b>	40 SF
<b>Is the material Asbestos Containing?</b>	Yes
<b>Type of Asbestos</b>	Assumed
<b>Condition</b>	Non-Friable
<b>Material Location</b>	Northwest bathroom

View of shower surround

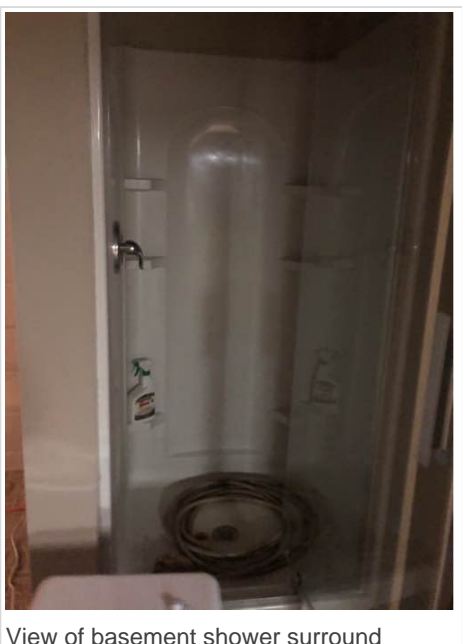
Material Description	Shower surround basement
Homogeneous Area	SS-2
Material Quantity	40 SF
Is the material Asbestos Containing?	Yes
Type of Asbestos	Assumed
Condition	Non-Friable
Material Location	Basement shower

View of basement shower surround

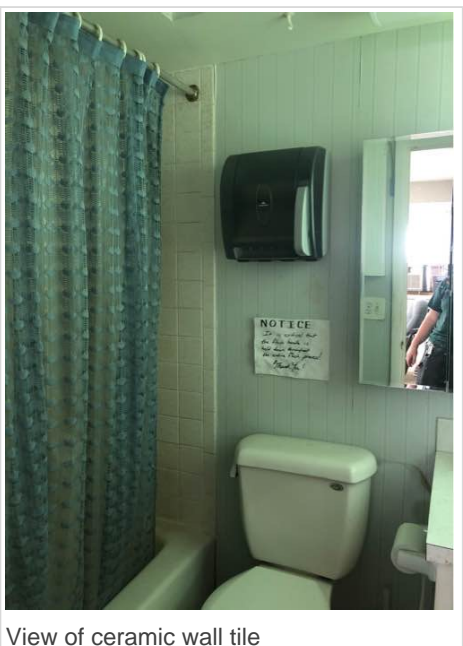
Material Description	Ceramic wall tile and adhesive, blue speckles
Homogeneous Area	CT-3
Material Quantity	40 SF
Is the material Asbestos Containing?	Yes
Type of Asbestos	Assumed
Condition	Non-Friable
Material Location	Northeast bathroom

<p>View of ceramic wall tile</p>	
------------------------	--	--

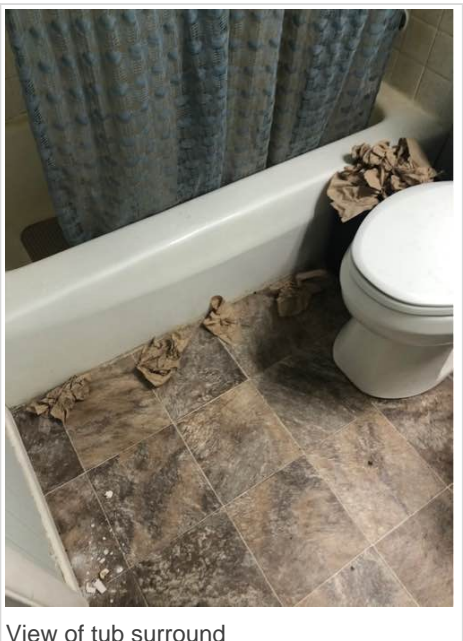
Material Description	Tub surround
Homogeneous Area	TS-1
Material Quantity	20 SF
Is the material Asbestos Containing?	Yes
Type of Asbestos	Assumed
Condition	Non-Friable
Material Location	Northeast bathroom

View of tub surround

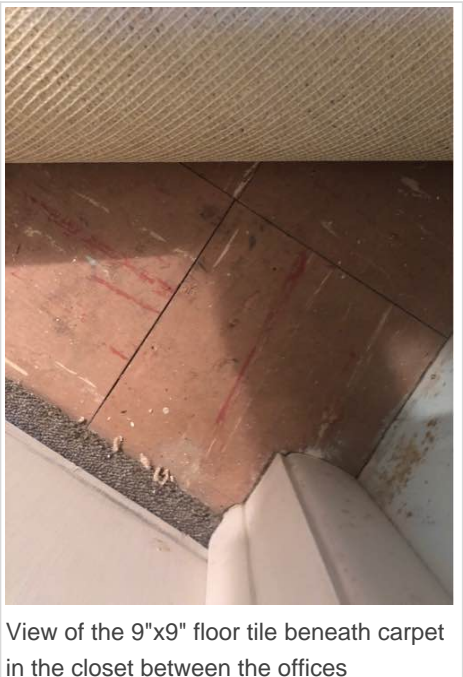
Material Description	9"x9" brown floor tile and mastic
Homogeneous Area	FT-1
Material Quantity	100 SF
Is the material Asbestos Containing?	Yes
Type of Asbestos	Assumed
Condition	Non-Friable
Material Location	Closet on main floor, between offices

<p>View of the 9"x9" floor tile beneath carpet in the closet between the offices</p>	
------------------------	---	--

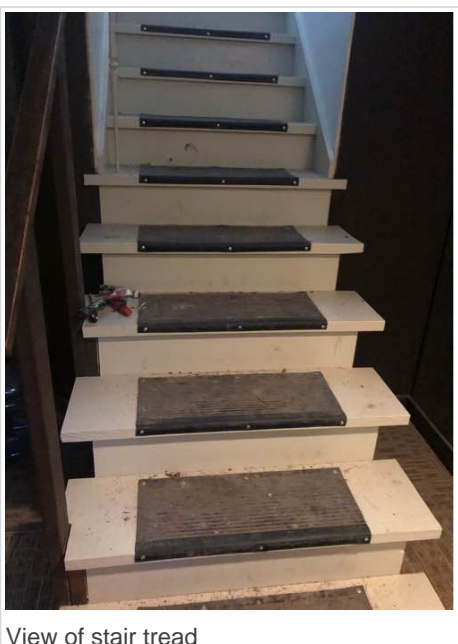
<b>Material Description</b>	Stair tread and mastic
<b>Homogeneous Area</b>	STM-1
<b>Material Quantity</b>	20 SF
<b>Is the material Asbestos Containing?</b>	Yes
<b>Type of Asbestos</b>	Assumed
<b>Condition</b>	Non-Friable
<b>Material Location</b>	Basement stairs

View of stair tread

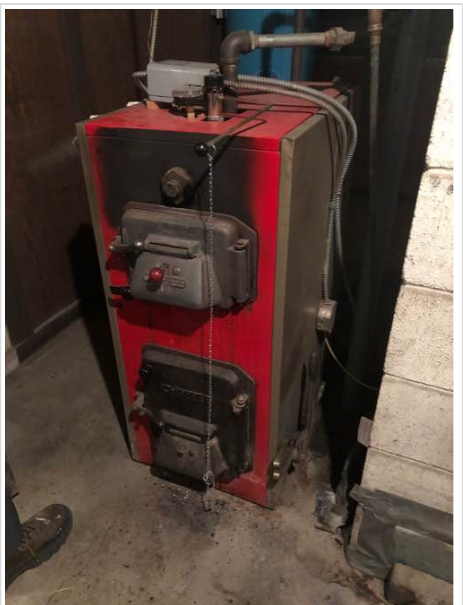
Material Description	Coal fired furnace
Homogeneous Area	CFF-1
Material Quantity	1 each. Gaskets potentially within furnace are assumed to be asbestos containing.
Is the material Asbestos Containing?	Yes
Type of Asbestos	Assumed
Condition	Friable
Material Location	Basement. Gaskets potentially within furnace are assumed to be asbestos containing.

<p>View of furnace in basement. Gaskets inside assumed asbestos (friable)</p>	
-----------------	---	--

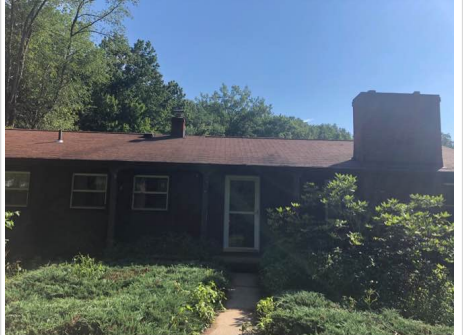
Material Description	Asphalt roof system	
Homogeneous Area	ASR-1	
Material Quantity	2000 SF	
Is the material Asbestos Containing?	Yes	
Type of Asbestos	Assumed	
Condition	Non-Friable	
Material Location	Exterior	
Material Photos

<p>View of roof</p>
